**Mobilize Limo**  
Standard Safety Equipment

2022

## SPECIFICATION

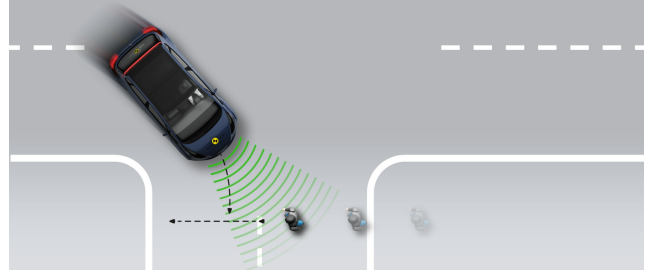
Pedestrian crossing a road into which a car is turning

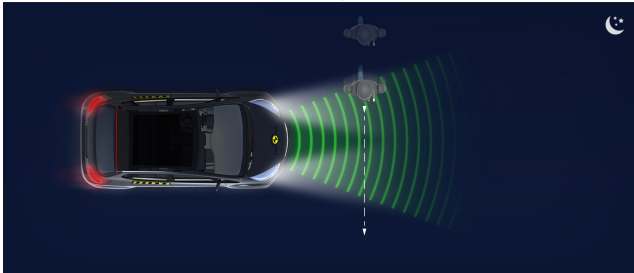
Adult crossing the road
