**BMW X1**  
Standard Safety Equipment

2022 ★★★★★

| Tested Model | BMW X1 2.0 diesel X-Line, LHD |

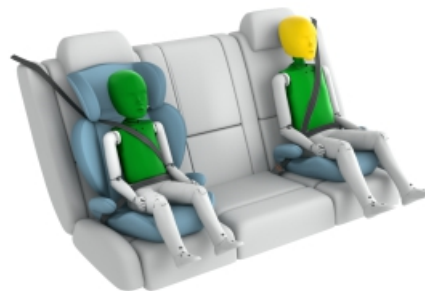
Lateral Impact

8 Pts

In both the frontal offset test and the side barrier impact, dummy readings indicated good or adequate protection of all critical body areas for both child dummies. The front passenger airbag can be disabled to allow a rearward-facing child restraint to be used in that seating position. Clear information is provided to the driver regarding the status of the airbag and the system was rewarded. All of the restraint types for which the X1 is designed could be properly installed and accommodated.

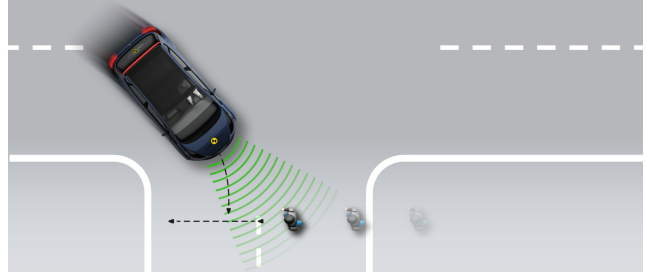
Pedestrian crossing a road into which a car is turning

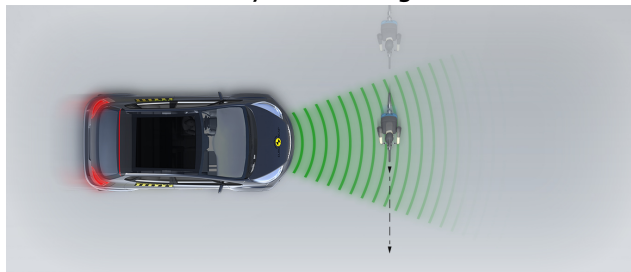
Cyclist crossing
